RIVER LAVANT RCA & WALKOVER SURVEY 2024

Site Assessments & Recommendations

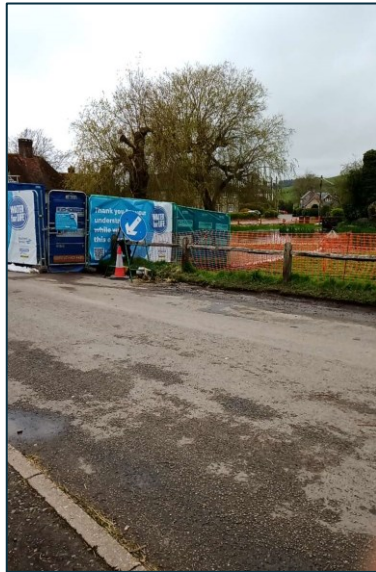
Southern water operating to reduce pollution from the sewage network at village pond

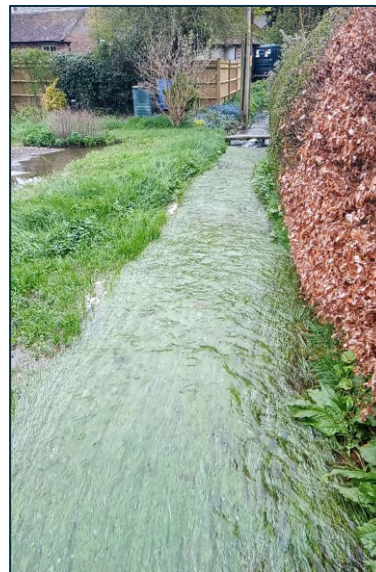
Terrestrial grasses dominant along channel.

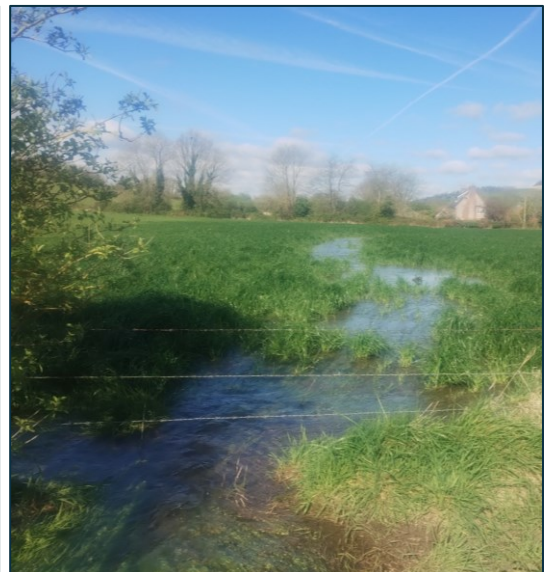
Springs issuing in arable field to the east of East Dean

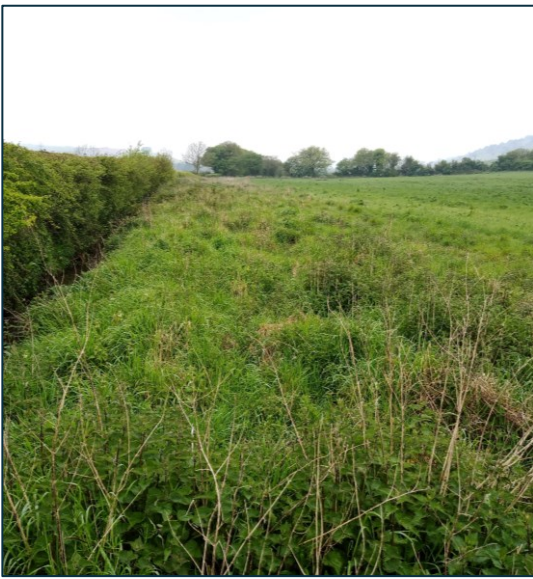
Wide riparian margin with small embankment and hedgerow that bounds Charlton Road along the left bank

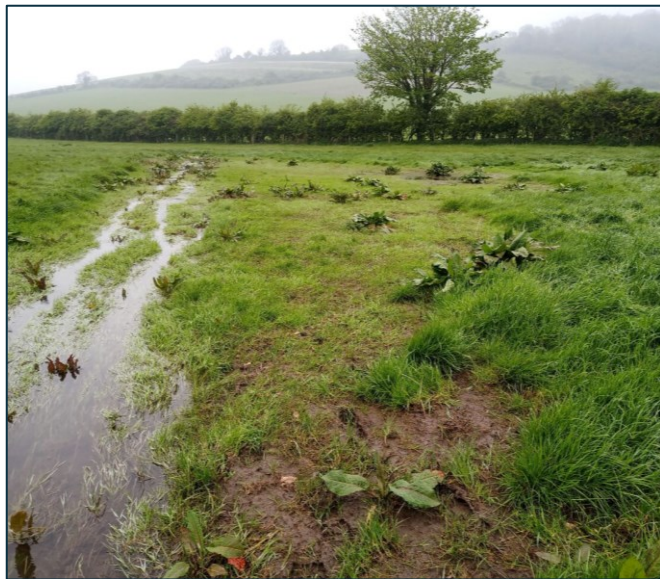
Wet flush along right bank of river with potential to enhance into scrape

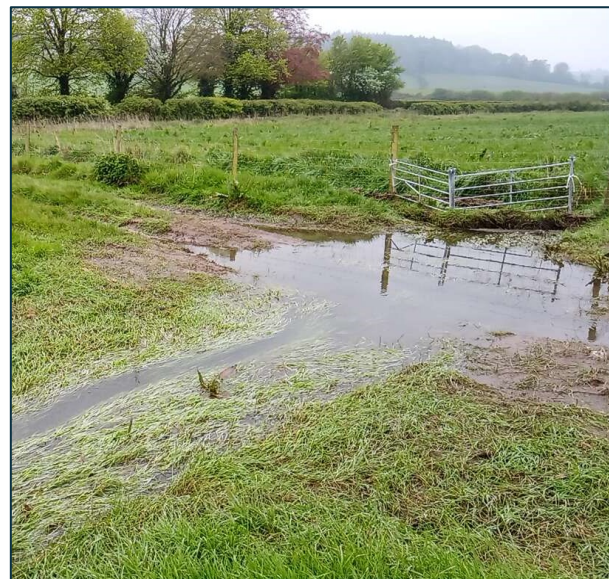
Muddy ford and dominance of terrestrial herbs and grasses through pasture field

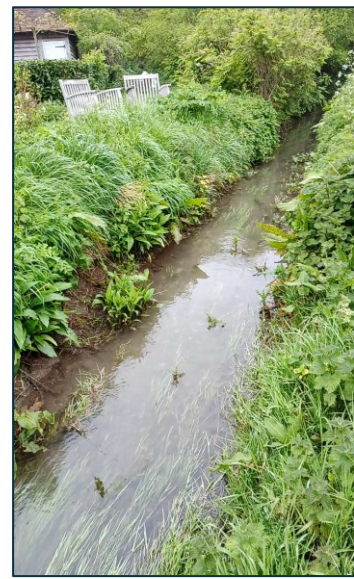
Over deepened and reprofiled channel at upstream end with discoloured water.

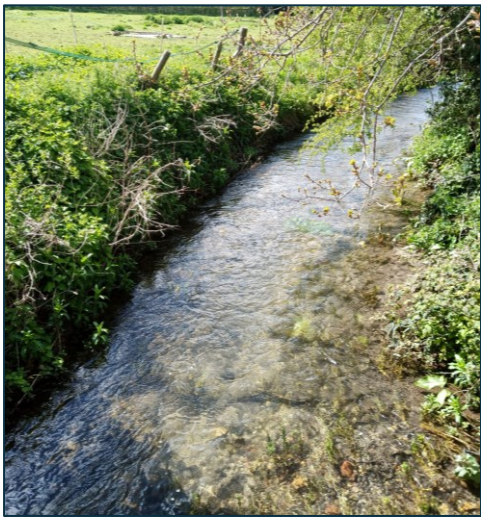
Horse grazed pasture fenced to bank top with nettle dominant along the bank sides

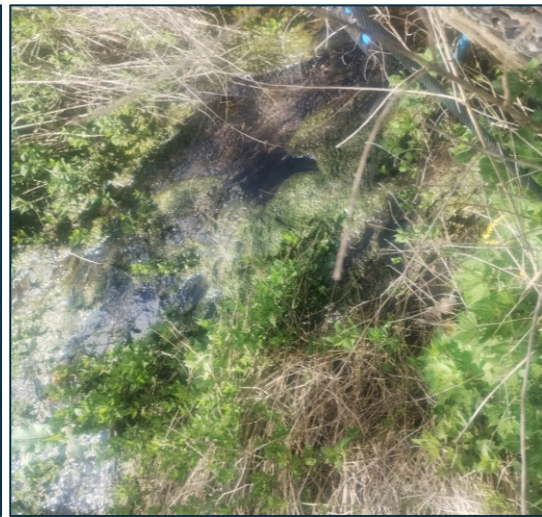
Filamentous green algae abundant along small tributary adjoining the Lavant from the south

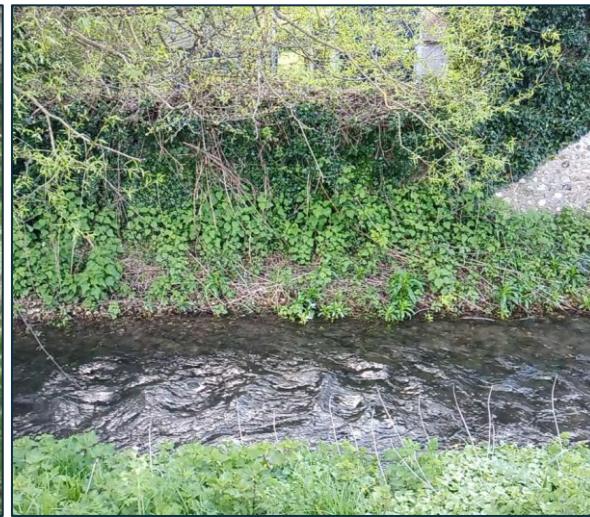
River restricted by flint wall and building along left bank at upstream end

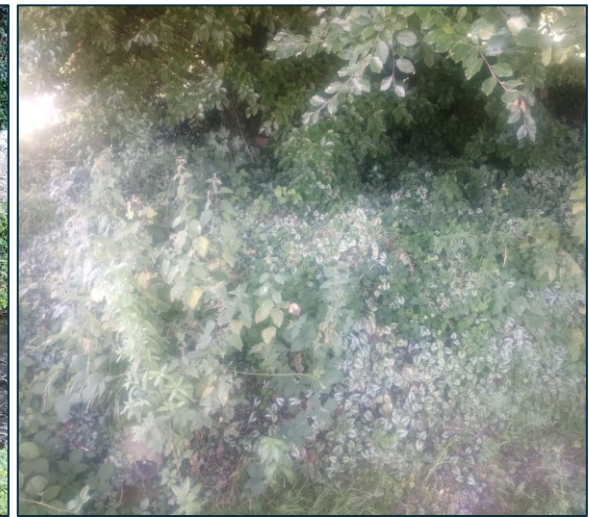
Variogated yellow archangel along left bank of river at start of section.

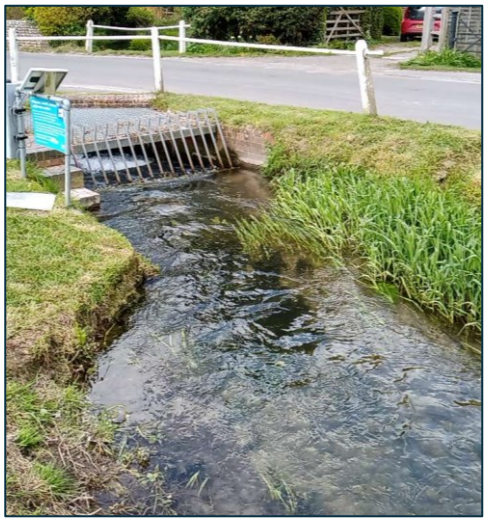
Culvert at downstream end with mown riverbanks and macrophytes.

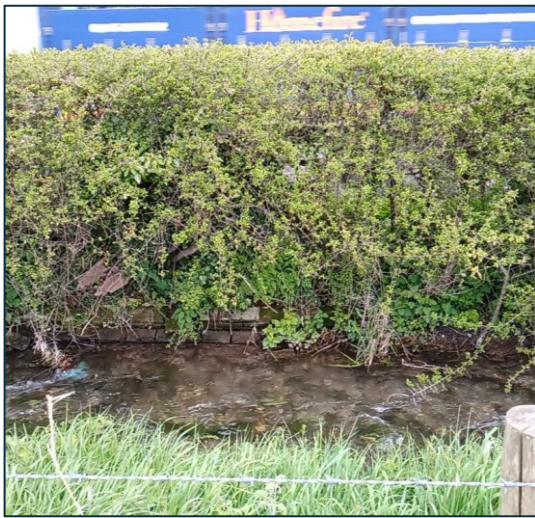
Brick reinforcements along right bank toe.

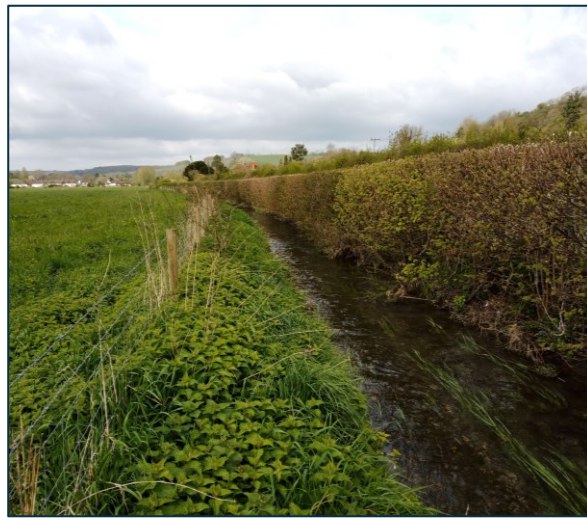
Over deepened along Charlton Road.

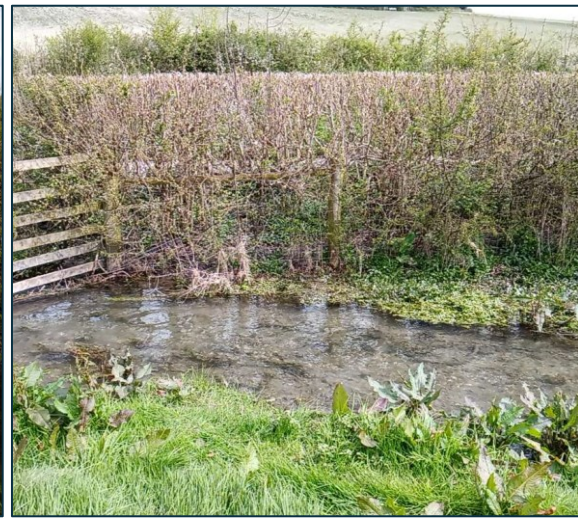
Discoloured water at upstream end of section.

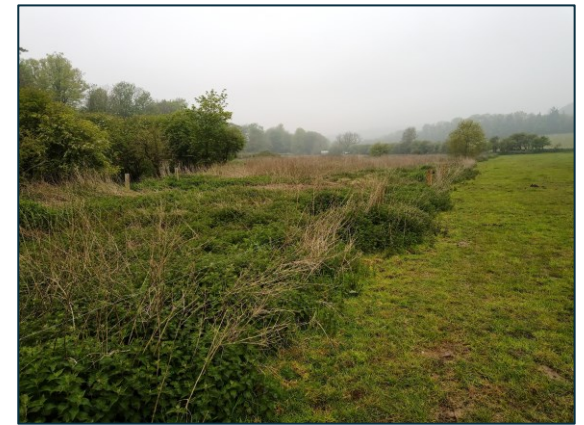
Wet field on right bank with opportunity to enhance with scrapes/pools.

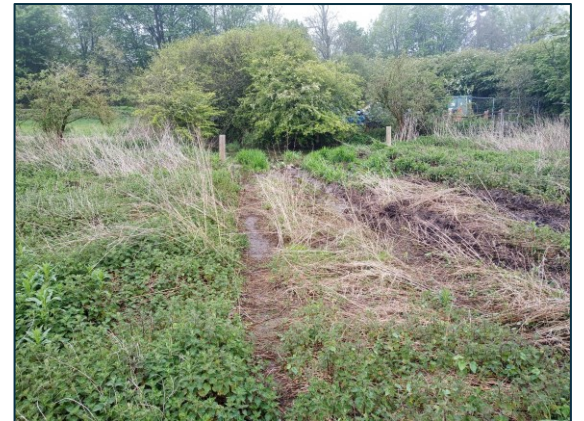
Muddy ford opposite the Southern Water pumping station.

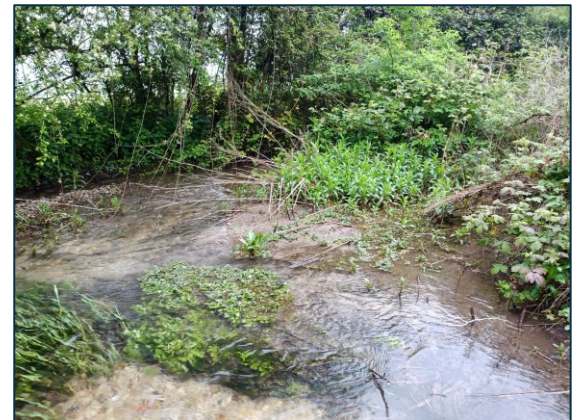
Sediment at confluence with tributary stream.

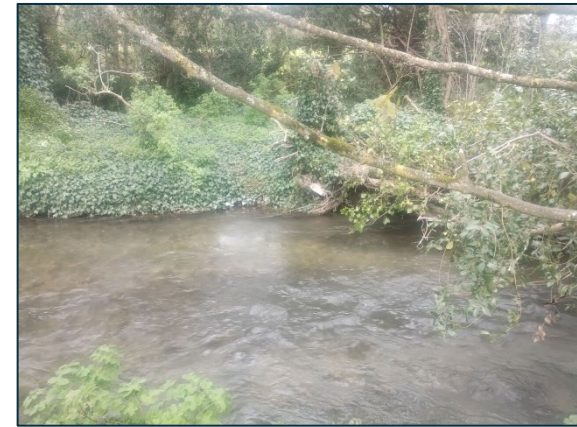
Fallen tree over channel.

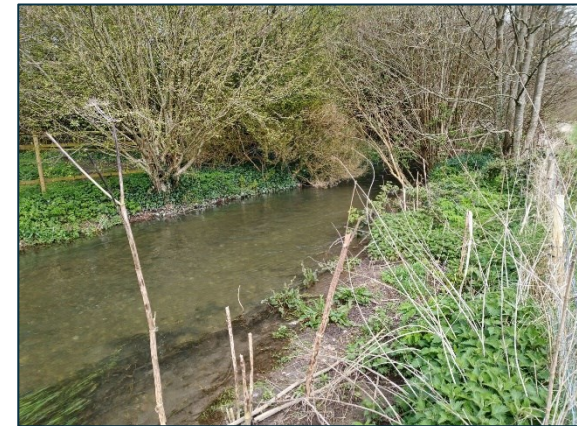
Riverbed predominantly unvegetated here.

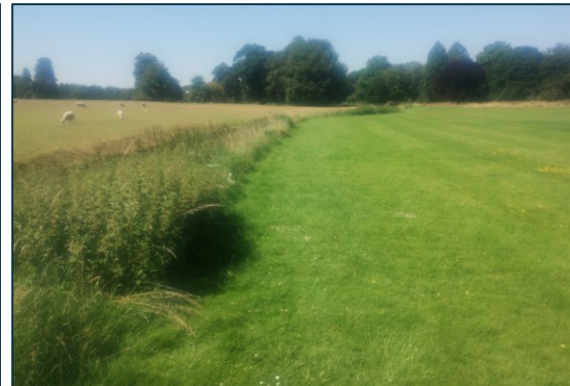
River is open with nettle margins and slightly perched in the front lawn of West Dean House.

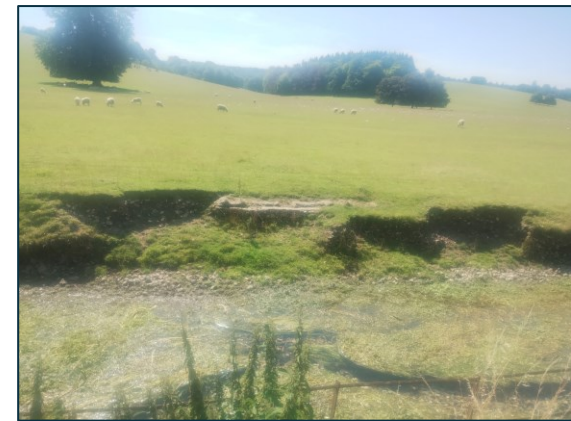
Left hand bank of river poached and partly reinforced.

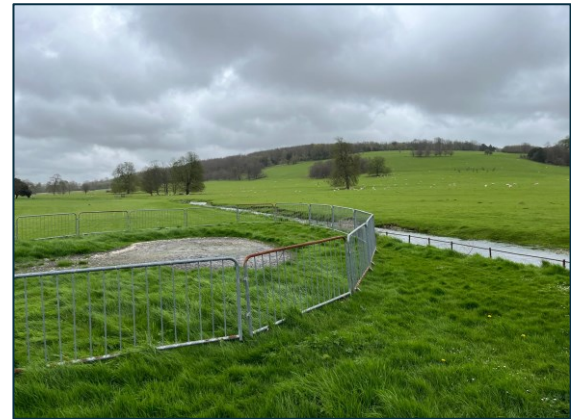
Sewage spill located on right bank close to river.

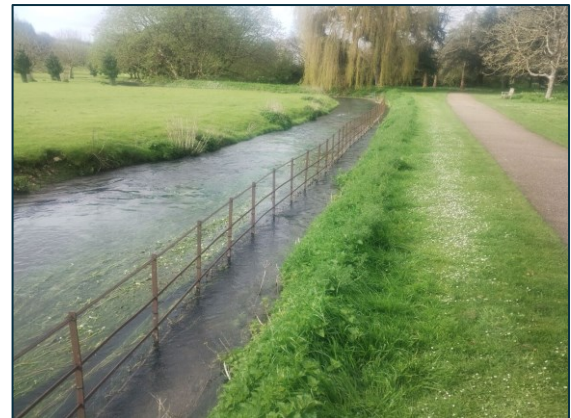
Wet fencing and reprofiled banks upstream of the Pentagon car park.

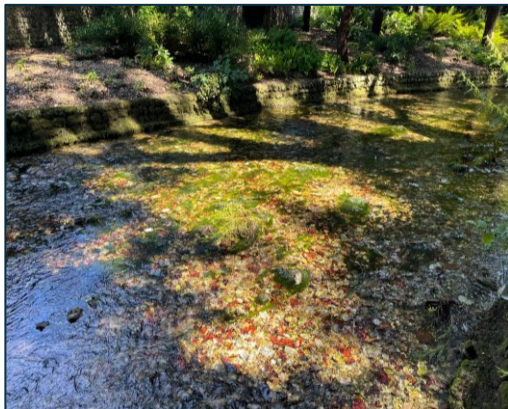
Hildenbrandia present in channel.

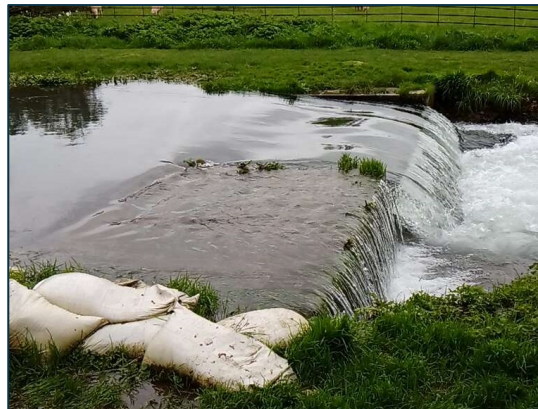
Weir at upstream end of section with sandbags in place to reduce breach of right bank.

- Removal of the upstream weir and associated reinforcements to allow natural flow of water and sediment transfer. This could be accompanied by some bank reprofiling and the creation of berms to create a faster flowing mid channel and marginal features.
- Reduce mowing along the bank tops at the upstream end to allow a wider margin of tall herbs and grasses to establish which will provide greater resilience to the river during receding flows.
- The straightened tributary could be enhanced by installing gravels along the banks to create a meandering course within the confines of the reinforced channel.
- *Mimulus spp.* should be removed from the downstream end to prevent further spread downstream.
- Create marginal bars with faster flowing mid channel by using dig and dump at downstream end (RL10a) to diversify flow and make the river more resilient during low flows.

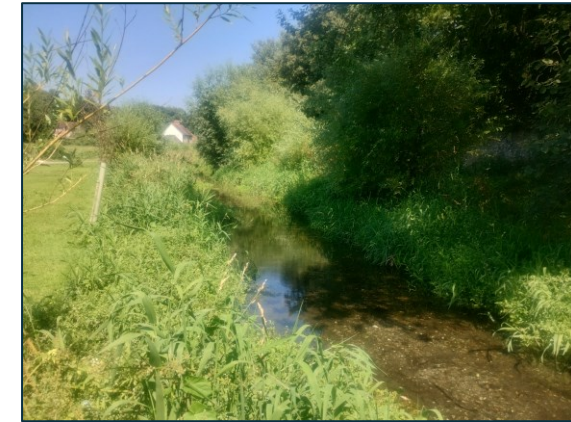
Diverse marginal vegetation growing along both banks where river flows adjacent to Church Lane.

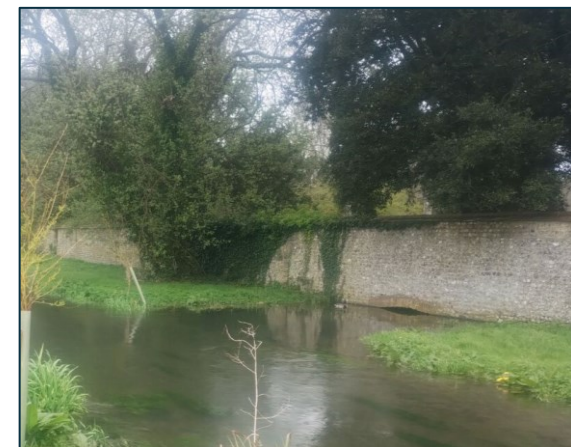
Side channel rejoins the Lavant under a small arch in the boundary wall.

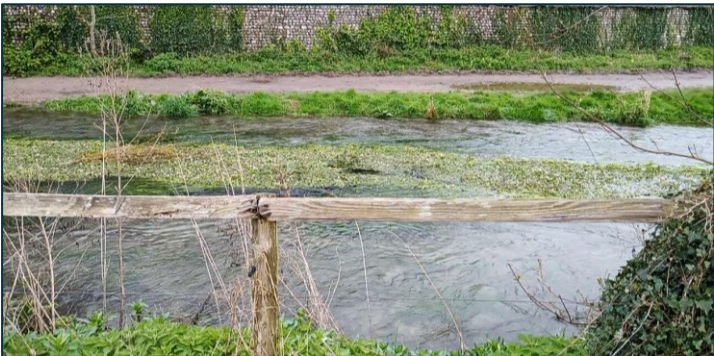
River over wide just downstream of Monarchs Way.

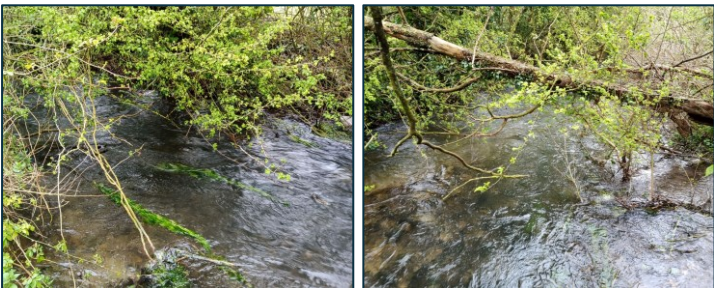
River overshadowed (left) and fallen tree (right).

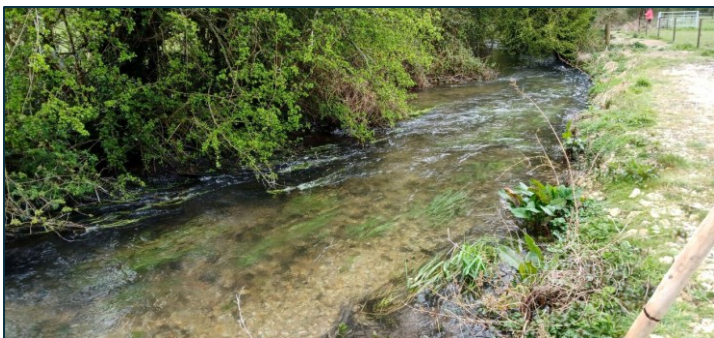
Chalk track encroached into right bank riparian margin.

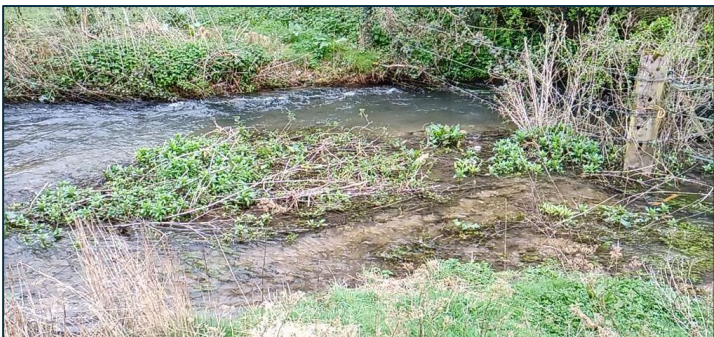
Vegetated mid channel bar and fencing over river at downstream end.

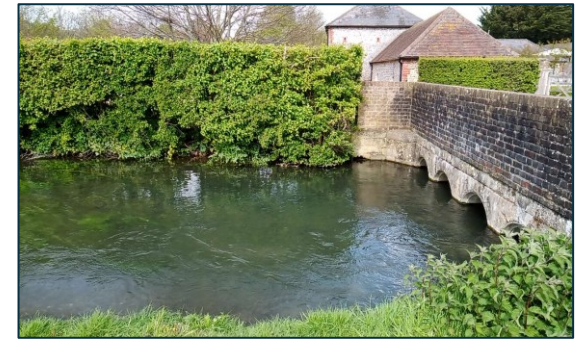
Culverts and hedgerow at Farbridge.

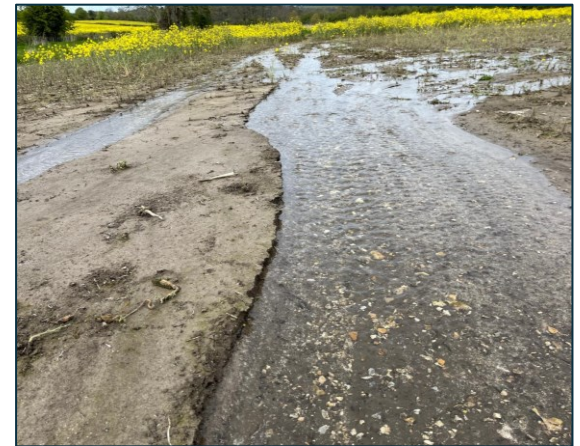
Overland flow through arable field from upstream breach (RL12).

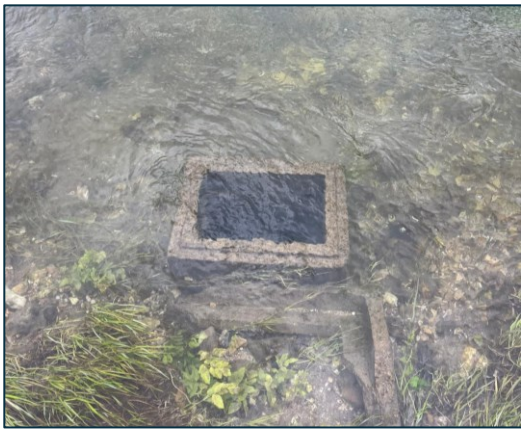
Open drain cover in channel at Farbridge.

- Replace and raise the drain cover at Farbridge to reduce the risk of sewage entering the river.
- There are also opportunities to restore marginal features by digging out pools to create bars, berms and a faster flowing mid-channel that would help improve morphological diversity and resilience during receding flows.

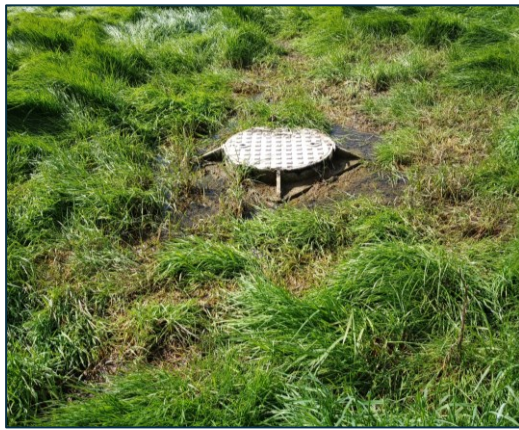
Drain in pasture field, appears to have overspilled.

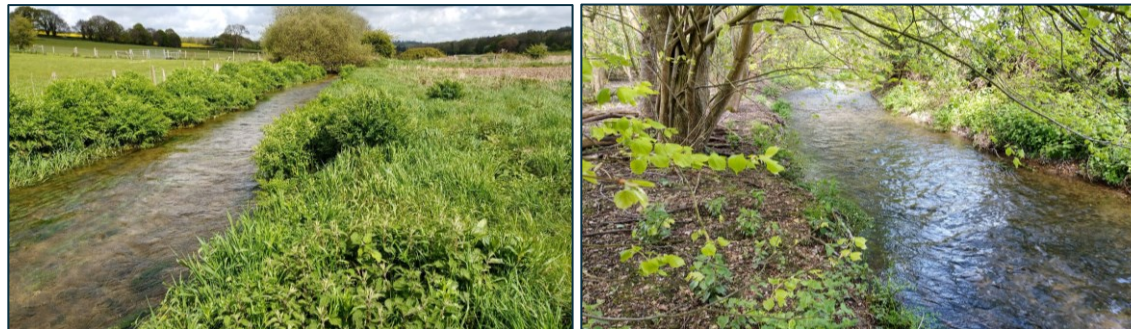
Photos show upstream RL14a (left) and downstream RL14b (right),

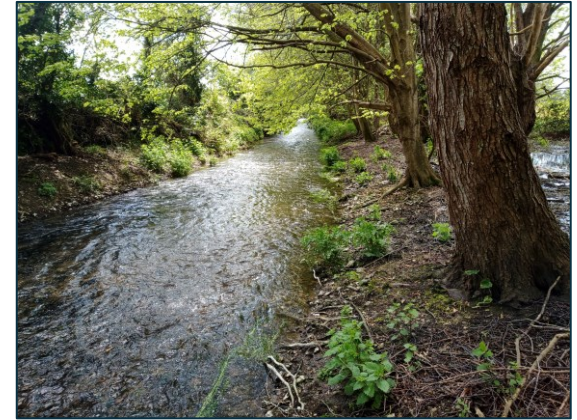
Channel overshadowed at downstream end.

- At the downstream end, scrub encroachment is tunnelling the river and some selective scrub removal would help diversify the margins allowing more light into the channel to encourage macrophyte growth which will help improve the rivers resilience during receding flows.

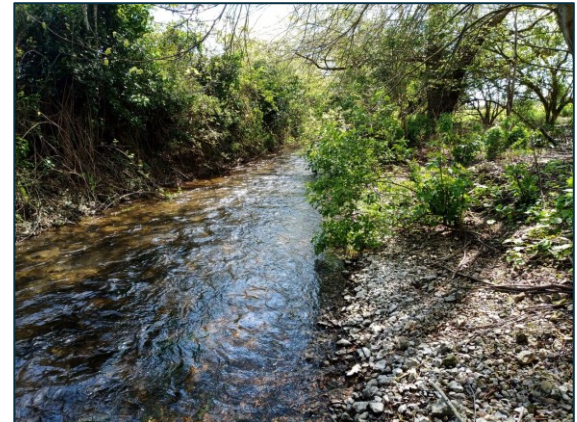
Dense bramble scrub along left bank.

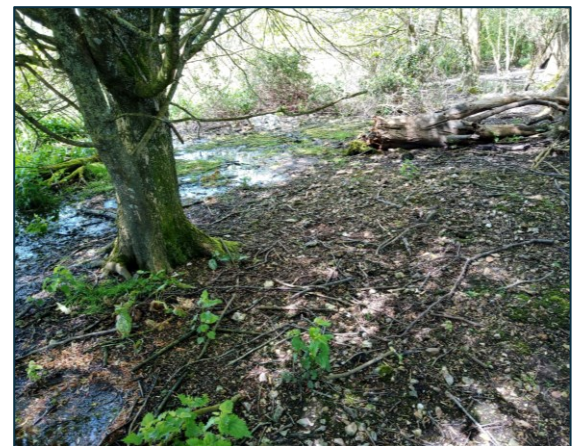
Wet woodland with limited understorey.

- Improvements to the woodland by removing dying ash, thinning the canopy (where required) and underplanting with planting native shrubs, would also be beneficial for the river by reducing risk of sediment run off and for biodiversity.

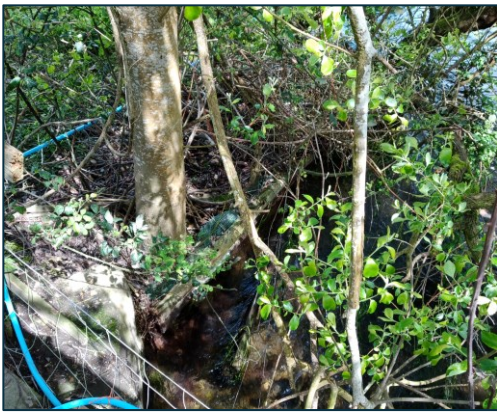
Right bank reinforcement associated with footbridge at start of section (LR14a).

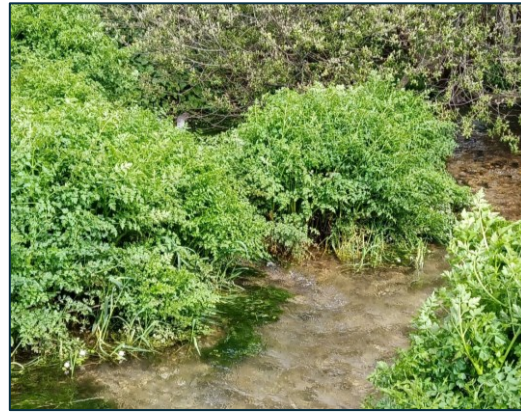
Willow and berm at start of section (RL14a).

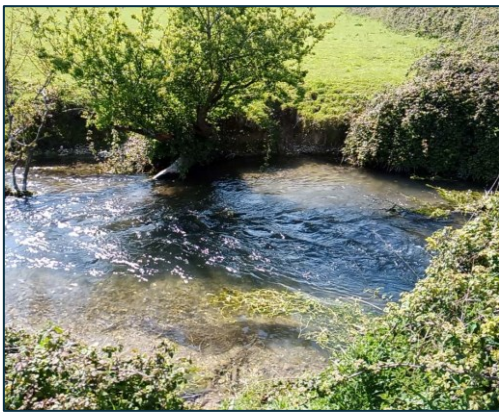
Upstream end with trees, scrub and faster flowing mid-channel.

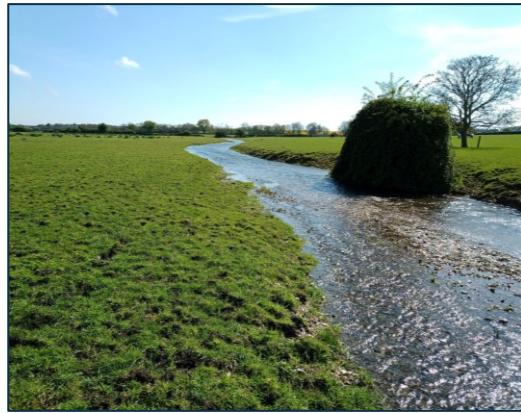
Mid channel gravel bar and poached banks.

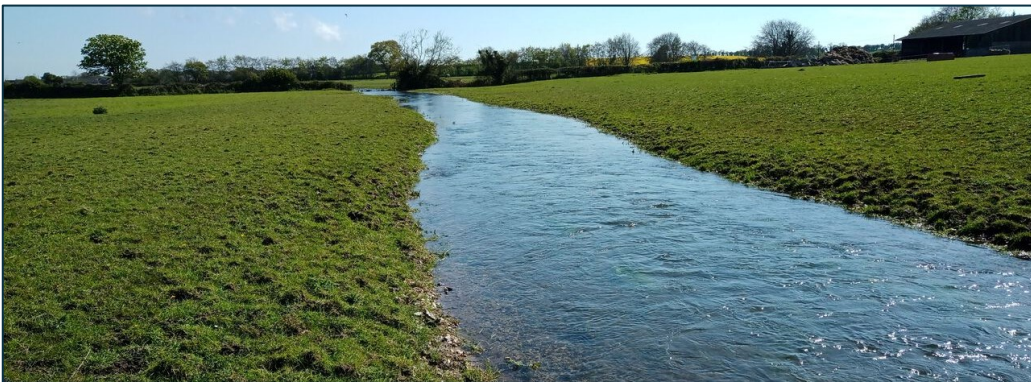
Treeless river with short, cropped grass and poached riverbanks and homogenous flow.

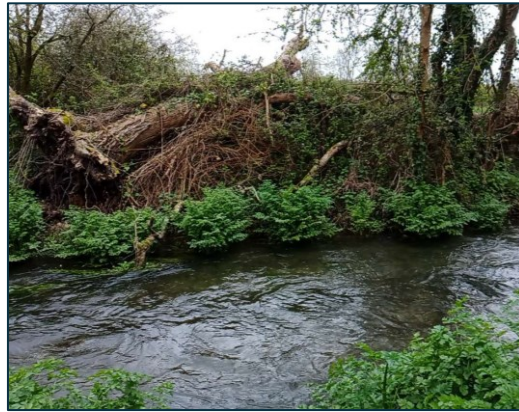
Fallen tree with exposed roots on right bank

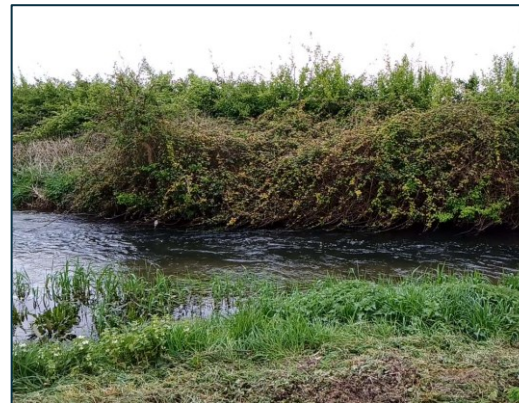
Scrub encroachment on right and marginal backwater on left at downstream end.

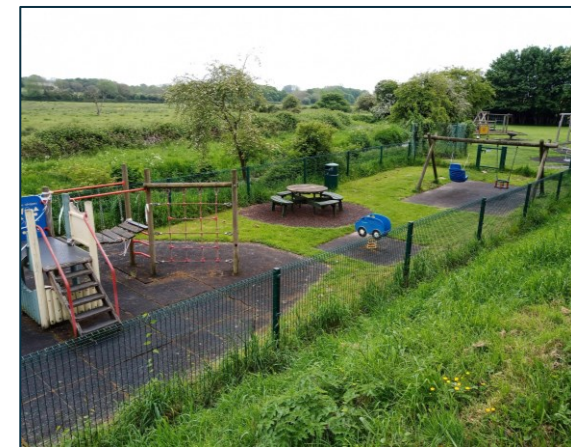
Playpark at Churchmead Close encroached into riparian margin.

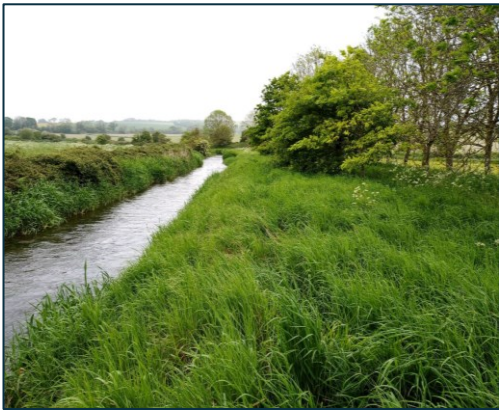
Wide riparian margin with trees and tall grass on left bank at upstream end.

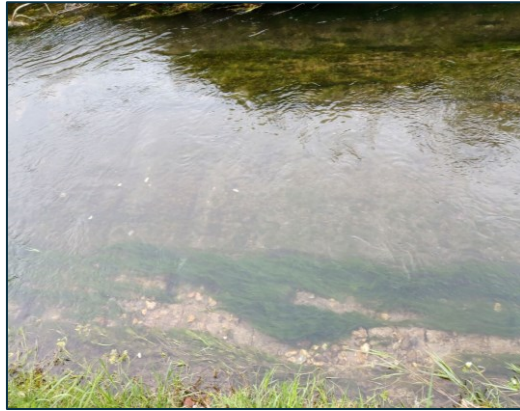
Reinforced bed associated with historical footbridge.

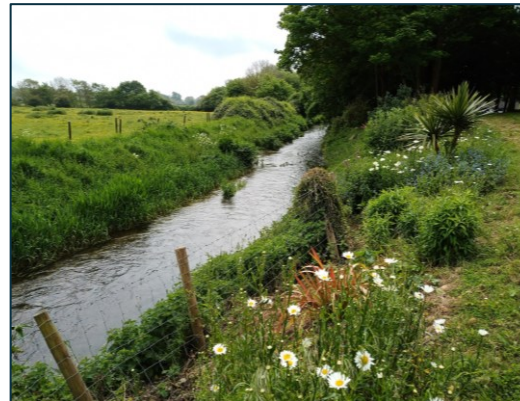
Ornamental planting on riverbank along Springfield Close.
