RIVER LAVANT RCA & WALKOVER SURVEY 2024

Site Assessments & Recommendations

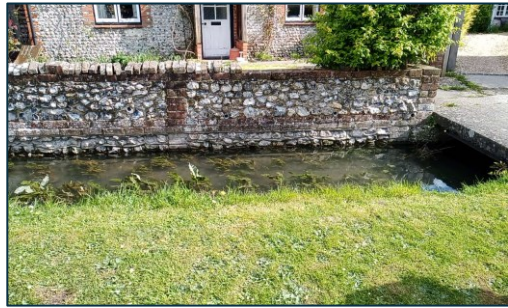
Discoloured water, mown left bank and wall confining river along the right bank.

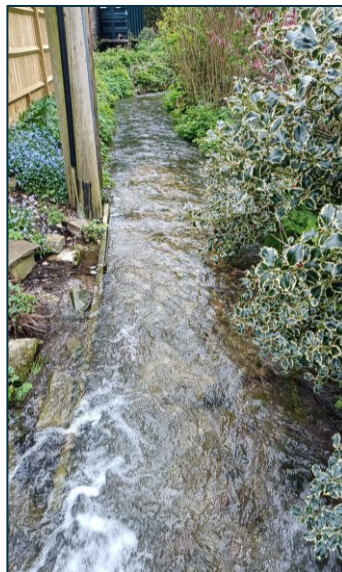
Wooden shuttering along stream

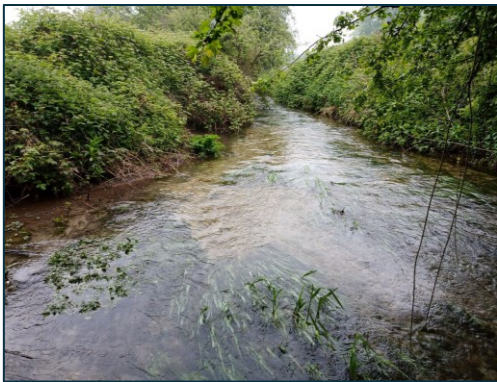
Dense scrub along both banks upstream of confluence with right bank tributary.

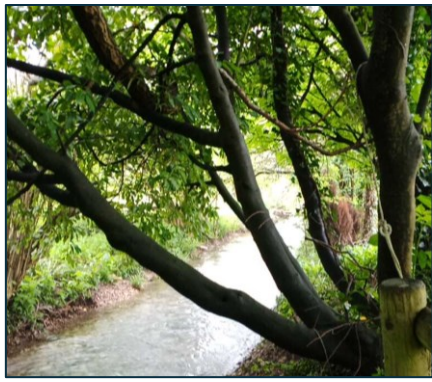
Cherry laurel along right bank adjacent to cricket field casting dense shade over the channel.

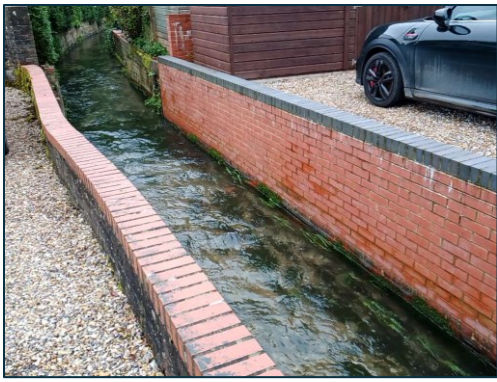
Reinforced banks with opportunity to install gravel bars along banks to create faster flowing mid channel and marginal features

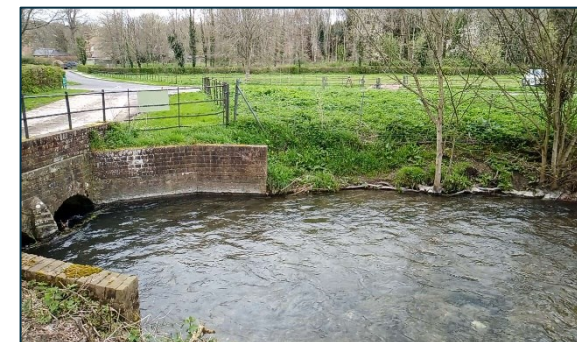
Culvert at downstream end.

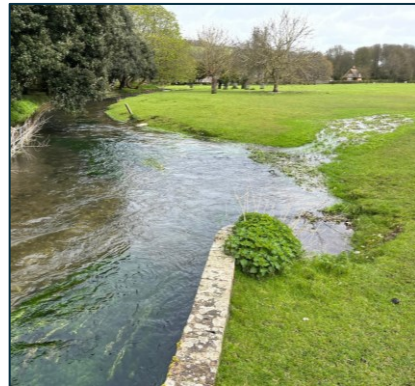
Drain issuing sewage from left bank and reinforced downstream.

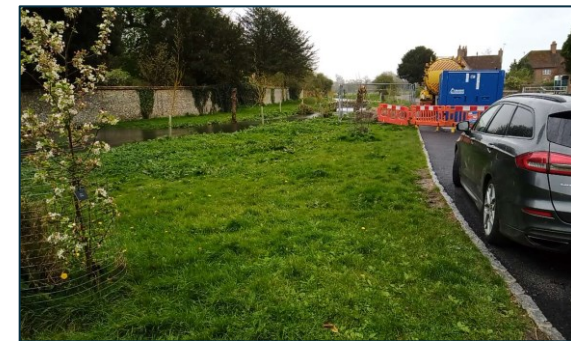
Southern water operatives pumping from network.

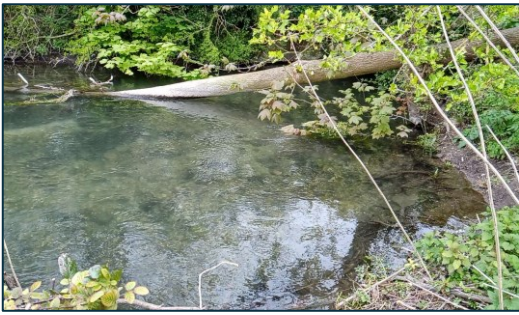
Fallen tree and back water downstream of culvert under Centurion Way.

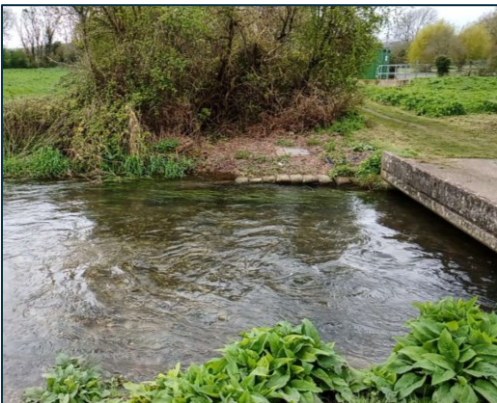
Concrete bridge with reinforcements on right bank

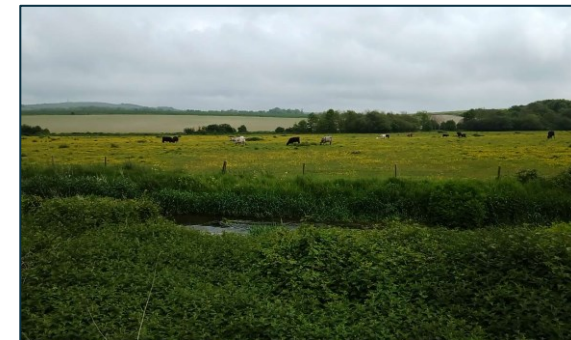
Pasture on left bank fenced close to bank top.

- Allowing more space for the river by setting back fencing where it is close to the bank top would allow a wider margin of taller herbs and grasses that will help protect the river from diffuse pollutants.

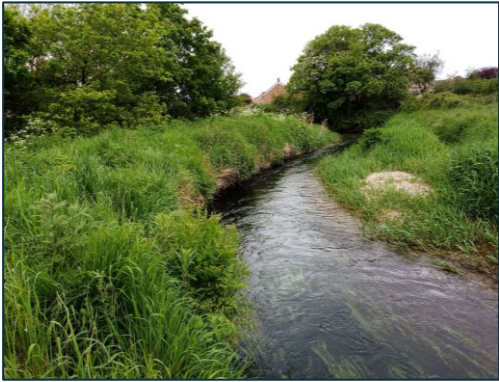
Gravel bar and berm on meander bend upstream.
