RIVER LAVANT RCA & WALKOVER SURVEY 2024

Site Assessments & Recommendations

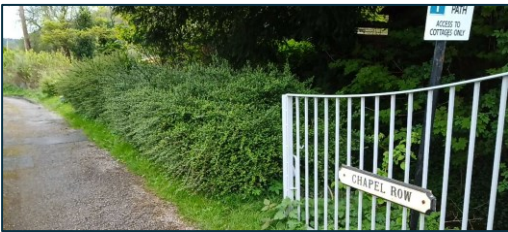
Cotoneaster spp present along the riverbank

- Removal of Cotoneaster from the bank top along Chapel Row. The shrub is overshadowing the river and is a Schedule 9 species so its presence along a rare chalk stream is undesirable.
- Relocating the compost heap away from the bank top in the allotments as this will be a source of ammonia into the stream.
- Restrict mowing of the riverbanks, particularly when the river is in flow as this will help capture surface run off from the adjacent road.
- Review agricultural cropping of the fields east of the village to reduce diffuse pollutants at the spring head.

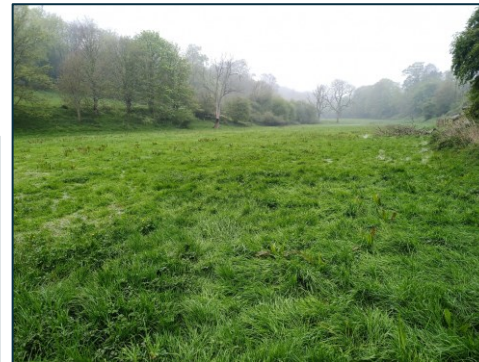
Here the water was sitting over gravels overlaid with terrestrial grasses and filamentous algae, suggesting poor water quality. The landform here is indicative of a historic lake and is indeed referred to by Ken Newbury in his book as "The Fountain". The tributary is then re-culverted under the farm before arising through cow pasture with water troughs on the bank top and farm tracks that were heavily poached by livestock before joining the River Lavant.

Photos showing "The Fountain" north of Cucumber Farm (right) and presence of filamentous algae over gravel substrate (left).

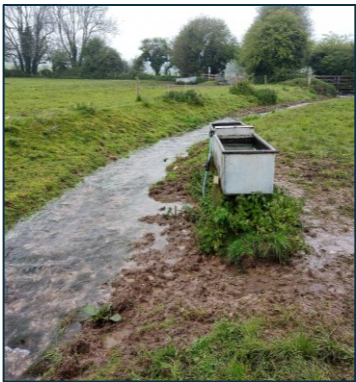
Cattle trough and poaching along tributary.

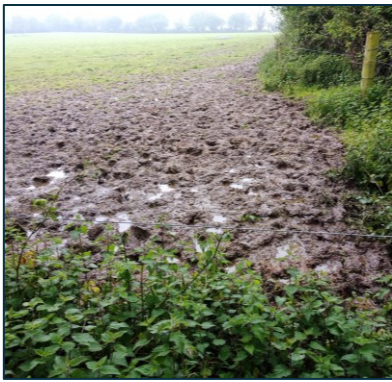
Cattle poaching in field corner on right bank top.

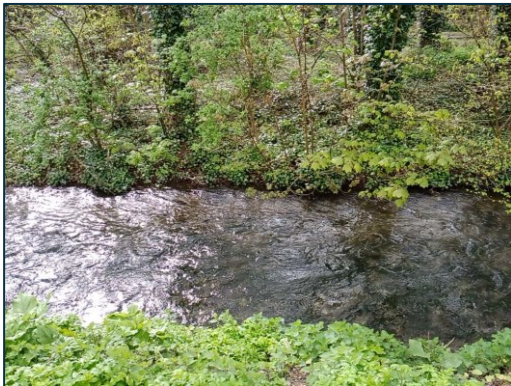
Wooded section of river at upstream end.

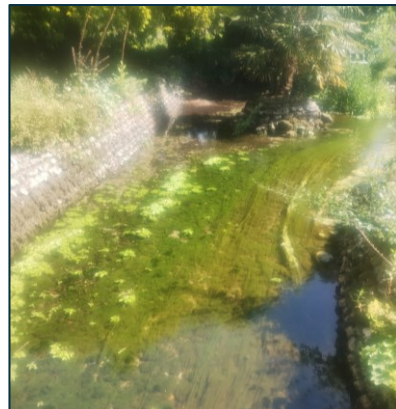
River reinforced through Spring Gardens where riverbed choked with *Cladophora*.

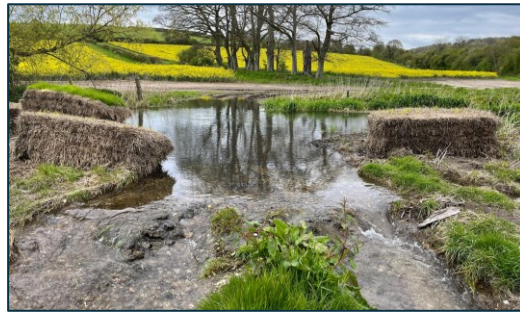
Channel breached at ford.

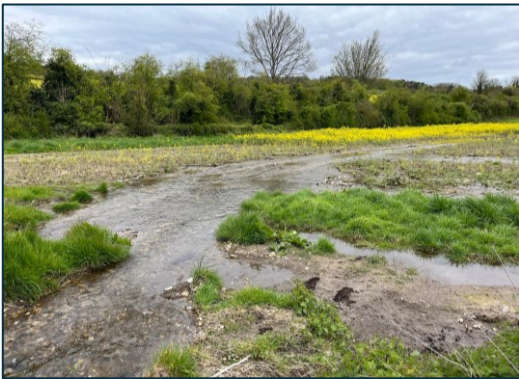
Out of bank flow through arable field.

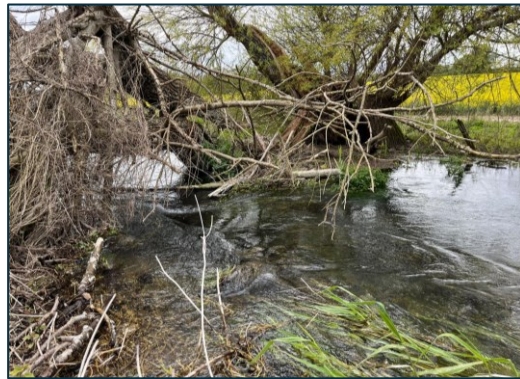
Leaning willow creating nice pool and chute.

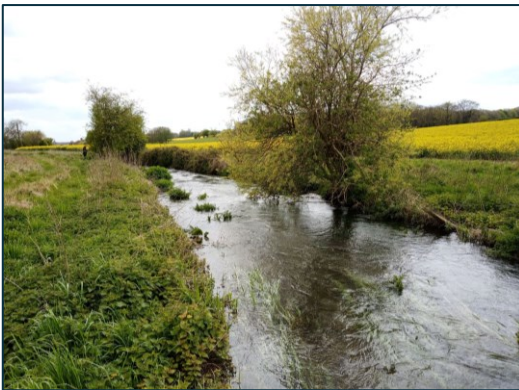
Wide riparian buffer strips with scattered trees along both banks

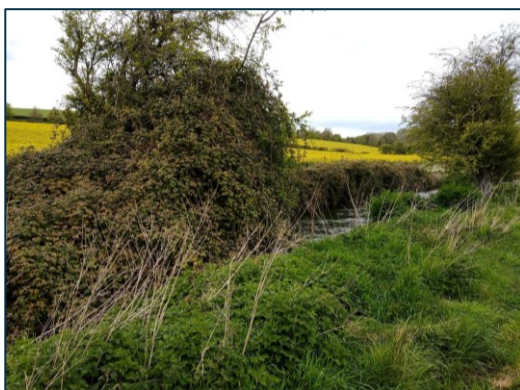
Short stretch of bramble scrub along right bank which is creating a nice chute where it is encroaching into channel.

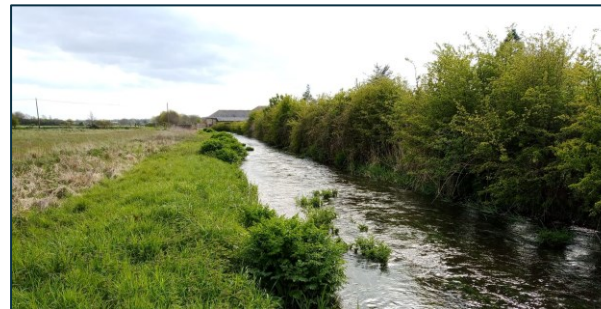
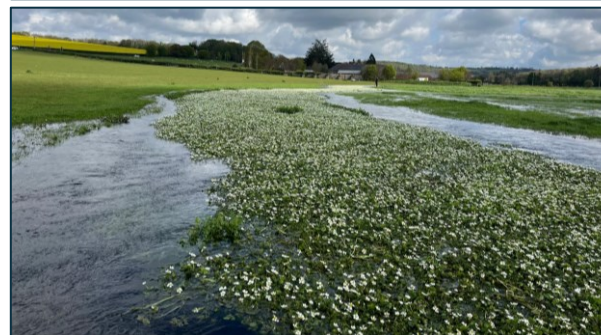
River upstream of Farbridge, (top); downstream of Farbridge (bottom).

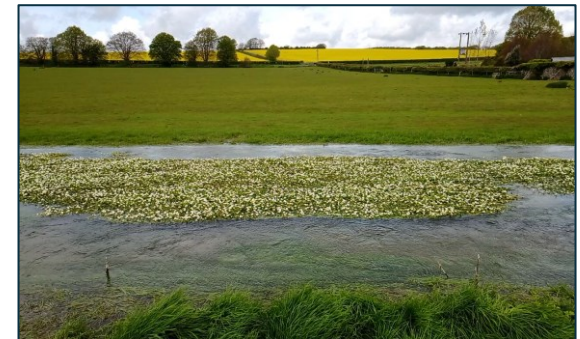
No marginal habitat through pasture field.

- Allowing a wide riparian margin to establish along the riverbanks by erecting temporary fencing when the pasture is grazed by sheep. This would help filter nutrients, provide habitat for river fauna and improve resilience during low flows.

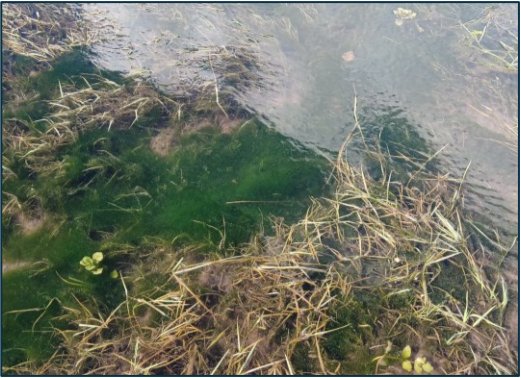
Filamentous algae in floodplain.

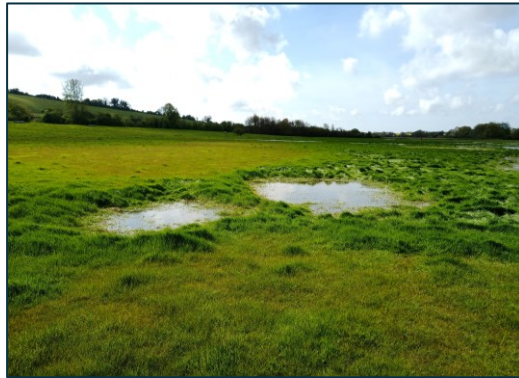
Pools in floodplain.

- Creating scrapes/ponds where water is sitting on the floodplain during peak flows. This would provide lateral refuges for riparian species during the dry phase and increase biodiversity value along the river corridor.

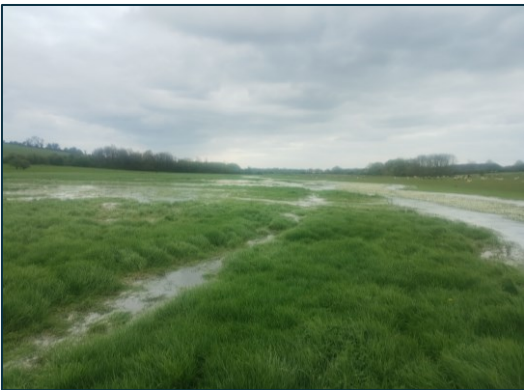
Historical water meadow channels through pasture field.

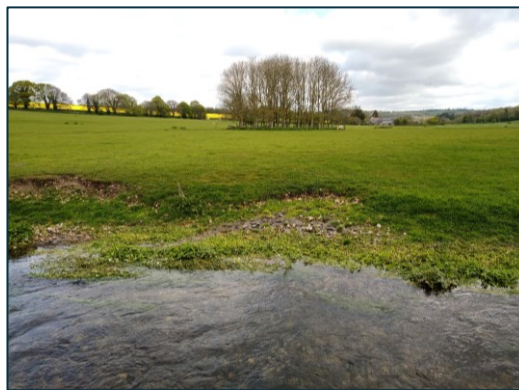
Poached and eroding riverbanks at downstream end.

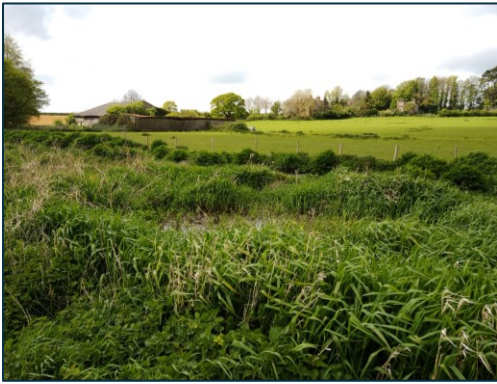
Pond in arable margin on left bank adjacent to river (RL14a).

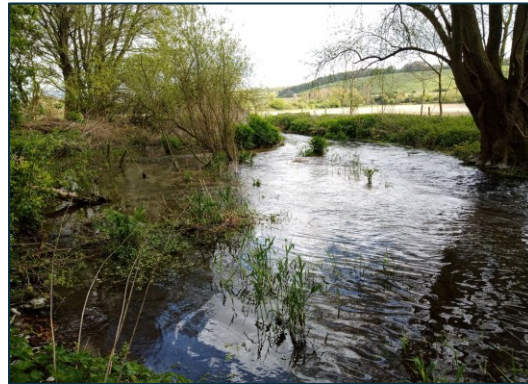
Marginal backwater d/s of ford (RL14b).

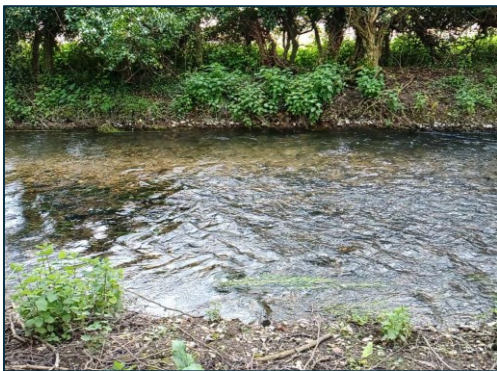
Homogenous bed with limited macrophyte growth where overshadowed by trees (14b).

- Downstream of Ox Barn, some light tree work would be beneficial. A good option would be to hinge a few trees into the channel to open the canopy and provide woody in channel features that would help diversify bed levels by causing localised scour and sediment deposition. This would provide more hydrological diversity and habitats.

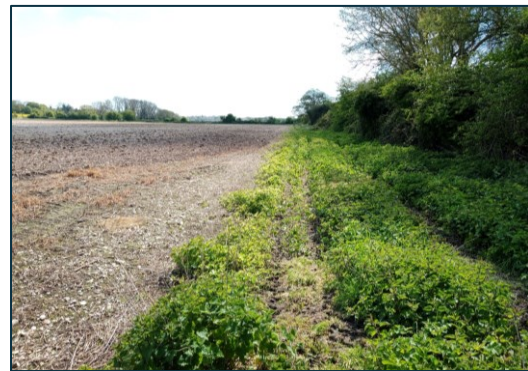
Arable margin (14b) with continuous trees and scrub on right which borders river.

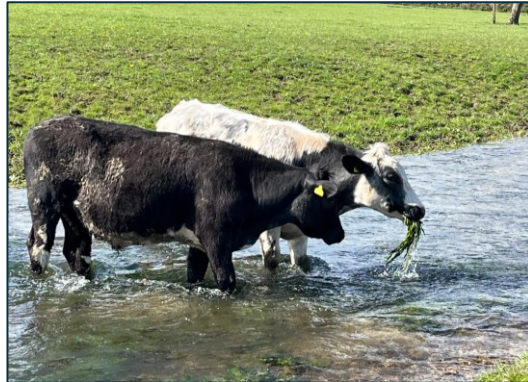
Livestock eating *Ranunculus peltatus*.

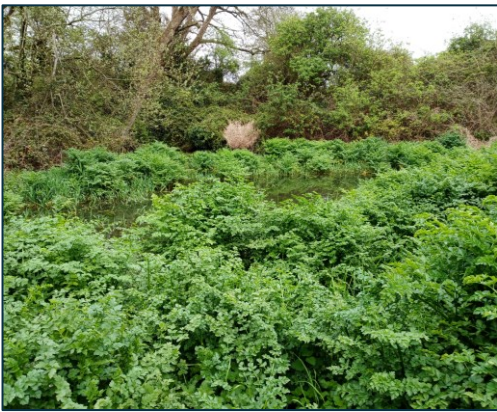
Restored pond fringed with *O. crocata*, *P. arundinacea* and *A. nodiflorum*

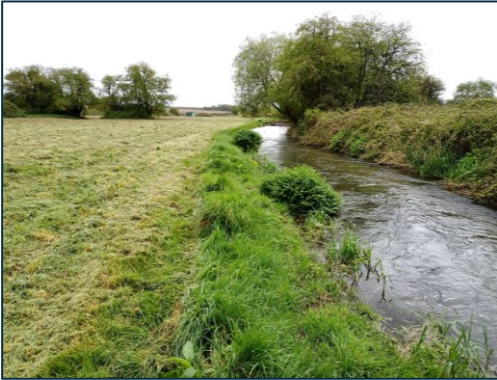
Mown grassland and continuous scrub

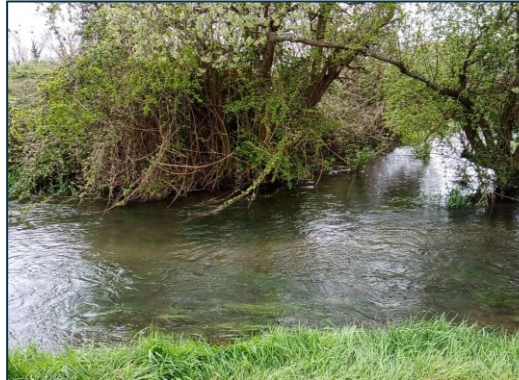
Tributary confluence

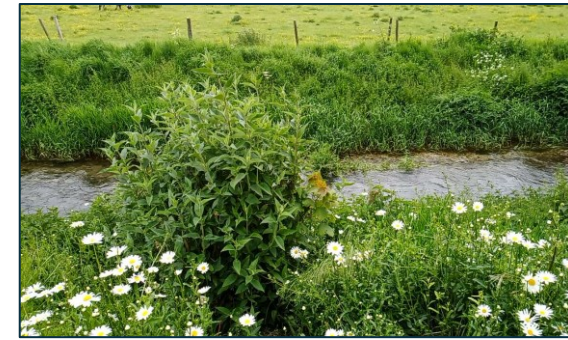
Buddleia along left bank by Springfield Close.

- Some thinning of scrub and strimming of nettle where it is encroaching over the channel would allow more light into the river.
- Engagement with the residents with riparian frontage to encourage planting of native and non-invasive species and if feasible, replacing problematic species such as Buddleia from the riverbanks.

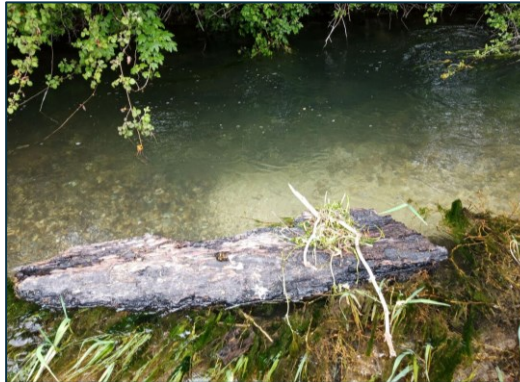
Large wood and pool on meander bend on upstream end.

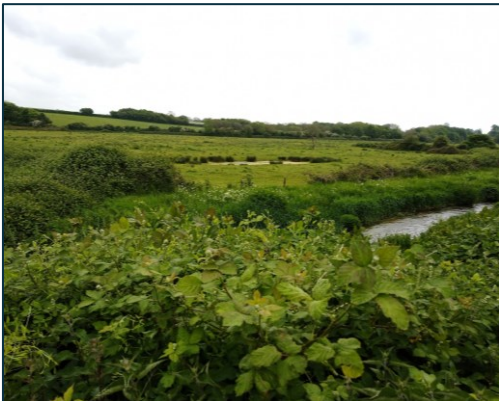
Pond in pasture field on left bank.
